Safety Bulletin - October 2018

Discolouration of Webbing

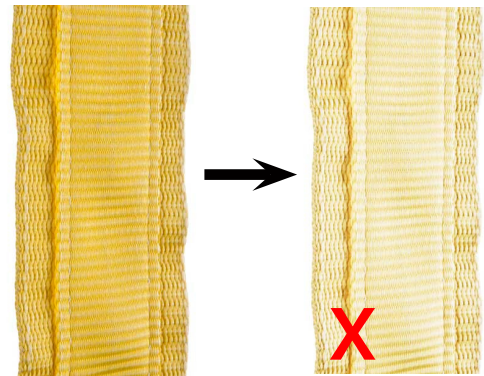
1. Ultraviolet Damage:

Ultraviolet damage is most commonly caused by prolonged exposure to direct sunlight. This weakens the fibres of the webbing which could lead to webbing failure if subjected to a shockload. UV exposure is unavoidable to a certain extent but it can be managed. Ensure that webbing is never stored in direct sunlight or underneath neon lights.

No UV exposure

UV exposure

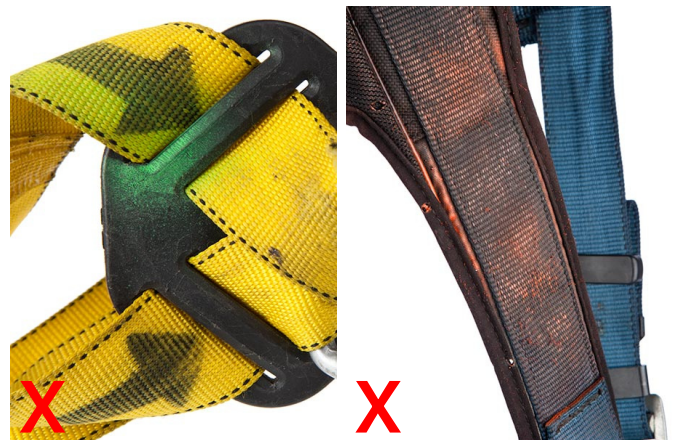
2. Chemical Damage:

Due to the nature of work at height, it is very frequently the case that technicians use chemicals such as paint, grease, waterproofing etc. Should webbing come into contact with any chemicals, it should be withdrawn from service until a detailed inspection can be conducted to determine the severity of the damage. Chemical contaminants can prevent the fibres from be able to stretch which can lead to a failure when subjected to a shockload. A secondary effect is that the chemical contaminants cover the webbing so that a detailed inspection cannot be conducted thoroughly. If this is the case, the equipment must be withdrawn from service and replaced.

Should equipment need to be marked, ensure it is not marked on any load-bearing parts of the equipment if the ink is not suitable to be used on work at height equipment.

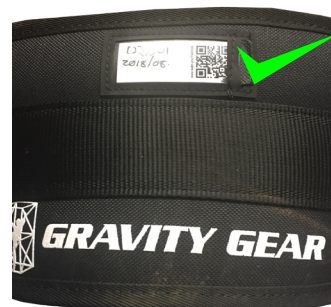
All Gravity Gear equipment has space allocated for the safe marking of equipment.
